FIRE SAFETY FOLLOW UP INSPECTION

Factory Name	Day Apparels Ltd		Factory ID	12483
Address	M H Tower, 21, Vogra, Gazipur – 1704 , Gazipur			
Initial Inspection Date	08-Dec-2016		Report Received Date	
Date of 1st Follow-up	30-Jul-2017	Date of 2nd Follow-up	16-Jan-2018	
Date of 3rd Follow-up	26-Jul-2018	Date of 4th Follow-up	28-May-2019	
Date of 5th Follow-up	22-Aug-2019	Date of 6th Follow-up	26-Dec-2021	
Date of 7th Follow-up	29-May-2022	Date of 8th Follow-up	10-Nov-2022	
Date of 9th Follow-up		Date of 10th Follow-up		
Date of 11th Follow-up		Date of 12th Follow-up		
Date of 13th Follow-up		Date of 14th Follow-up		
Date of 15th Follow-up		Date of 16th Follow-up		
Date of 17th Follow-up		Date of 18th Follow-up		
Date of 19th Follow-up		Date of 20th Follow-up		
Inspected by	Md. Sadid Rahman

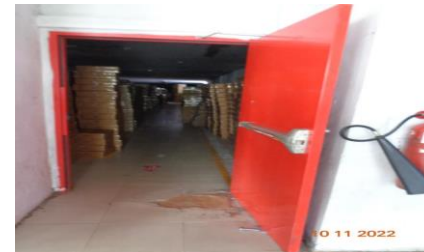
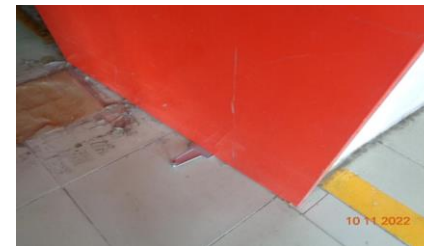
Item No	Inspection Observation	Inspection Recommendation	Timeline given	Comments after Physical Inspection	Supposed to complete(DD /MM/YYYY)	Final Action Plan (Factory)	Status on the date of Inspection	Pictorial Evidence
3	Rooms used for storage of combustible materials are not separated from East side embroidery room and South side day-care and medical room.	Rooms used for storage of combustible materials shall be separated from the surrounding occupancy with a minimum 1 hour construction.	within 3 months	<p>On 14-02-17: Timeline has been approved. Factory shall complete work within timeline as per Accord recommendation</p> <p>On 30/07/2017: Factory has imported fire door. Factory management confirms that they will install fire door and complete this issue within 30th September 2017.</p> <p>On 16/01/2018: Installation of fire door is going on for dedicated storage rooms. Unsealed opening shall be sealed for proper fire rated separation.</p> <p>On 26/07/2018: Partially Corrected.</p> <p>On 28/05/2019: Fire separation work for storage room in ground floor as well as 1st floor (Newly constructed finished goods store) has not been completed.</p> <p>On 22/08/2019: No action has been taken since last follow-up inspection.</p> <p>On 06/11/2019 (Special Inspection): Not Checked.</p> <p>On 26/12/2021: Factory has installed fire doors. Fire doors were found open using external objects. Interfacing of fire door could not be checked as fire alarm panel was found inactive.</p> <p>On 29/05/2022: The fire door has been installed. unsealed penetration was found above the door. The Factory shall seal all the penetration.</p> <p>On 10-Nov-2022: Progress has been observed but not corrected yet. Unsealed penetration has not been found however storage rooms are not separated due to non functional fire door accessories, missing and damaged hardware throughout 1st and ground floor of building. Some cases door has been found manually open condition.</p>	21-Apr-2017	Corrected	In Progress

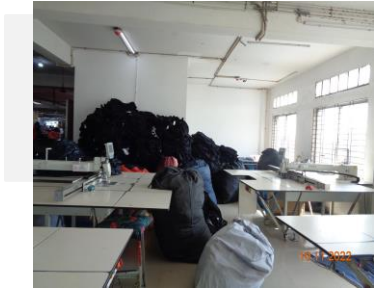
22	New Finding (3rd Follow Up): Inspection, testing and maintenance of the fire pump system is not in accordance with NFPA 20.	Inspect, test and maintain the fire pump system and keep written records on-site, in accordance with NFPA 20 and ACCORD standards.	Within 2 months	On 16/01/2018: New Finding On 26/07/2018: Integrated part of standpipe system. On 28/05/2019: It is an integrated part of fire fighting system. On 22/08/2019: It is an integrated part of fire fighting system. On 06/11/2019 (Special Inspection): Not Checked. On 26/12/2021: It is an integrated part of fire fighting system. On 29/05/2022: It is an integrated part of fire fighting system. On 10-Nov-2022: It is an integrated part of fire fighting system.	16-Mar-2018		In Progress	ADD PHOTO
23	New Finding (4th FU): Areas used for combustible storage are not separated by fire-rated construction.	Provide dedicated storage rooms separated by minimum 1-hr fire-rated construction. Where separate storage rooms are not feasible, provide defined storage areas and limit the storage arrangement as follows: - Maximum height of 2.4m and maximum area of 23m2 - If sprinkler protected: maximum height of 3.66m and maximum area of 93m2 Separate areas of unenclosed combustible storage by a minimum clear distance of 3m.	Within 1 month	On 28/05/2019: New Finding On 22/08/2019: In progress. On 06/11/2019 (Special Inspection): Not Checked. On 26/12/2021: Not corrected. On 29/05/2022: Not corrected. On 10-Nov-2022: Corrected. Factory shall ensure that storage has been maintained as per recommendation in all location including 2nd Floor.	28-Jun-2019	Removed all combustible material from the area .	Corrected
